YOUR INSPECTION REPORT

123 Any St
Georgetown, ON

Friday, October 8, 2021

RE: Report No. 1004, v.2
123 Any St
Georgetown, ON

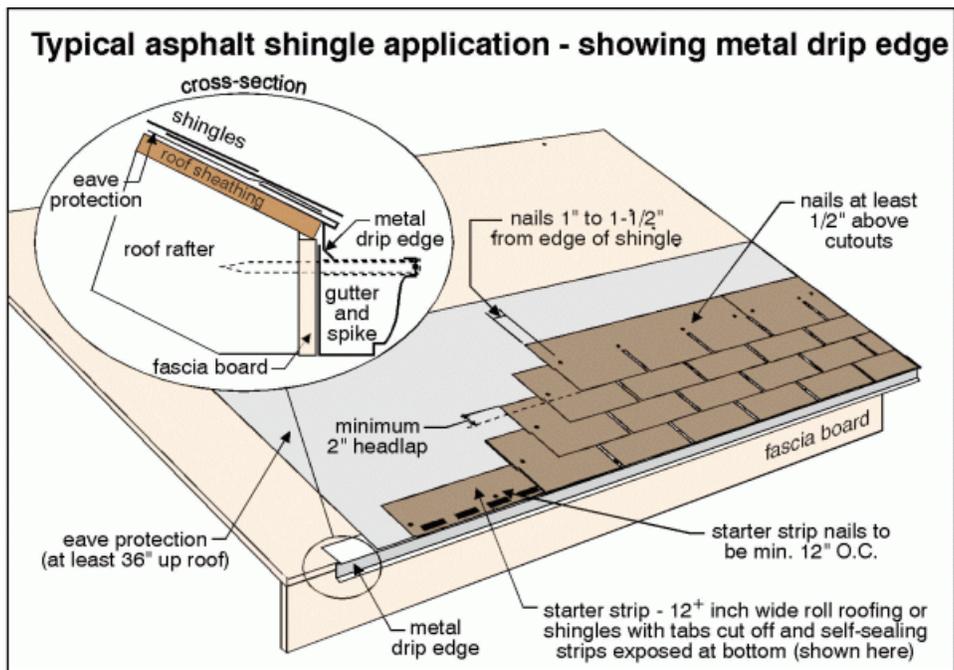
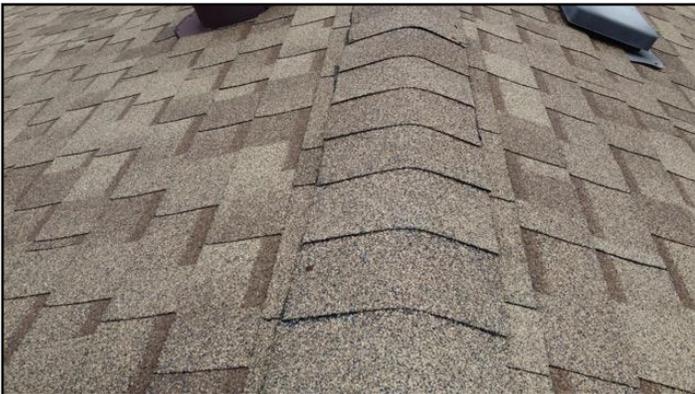
1. Condition: • [Exposed fasteners](#)

Implication(s): Chance of water damage to structure, finishes and contents

Location: Throughout

5. Exposed fasteners

6. Exposed fasteners

Task: Repair

Time: As soon as practical

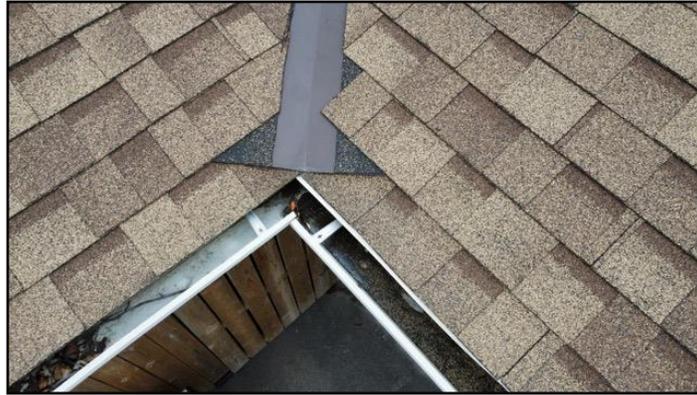
2. Condition: • [Too short](#)

Implication(s): Chance of water damage to structure, finishes and contents

9. Too short

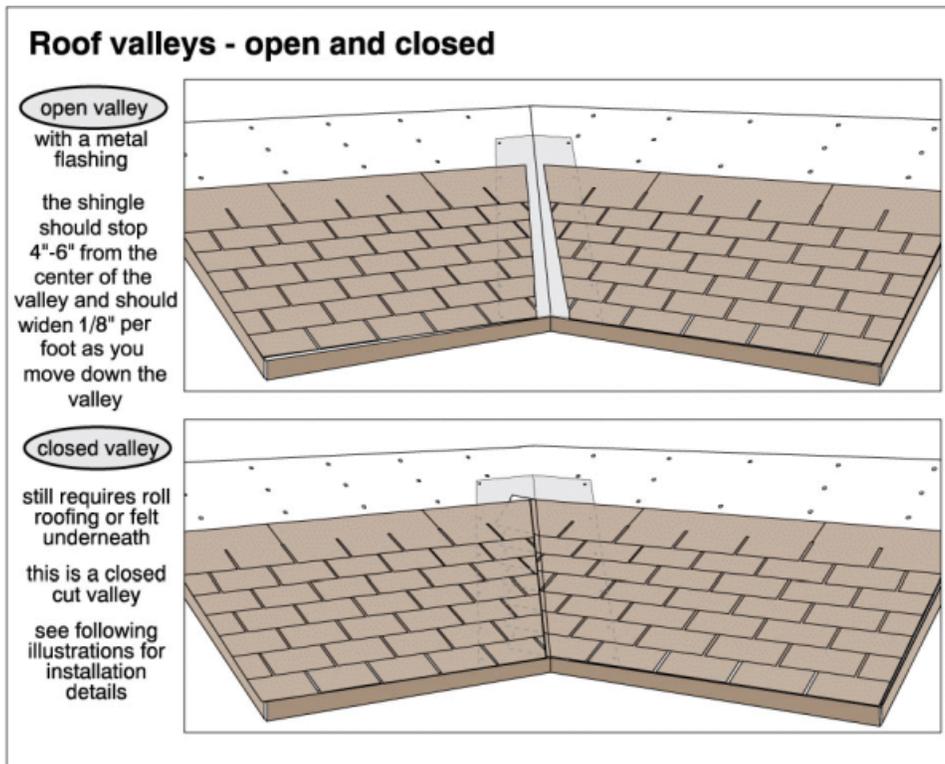
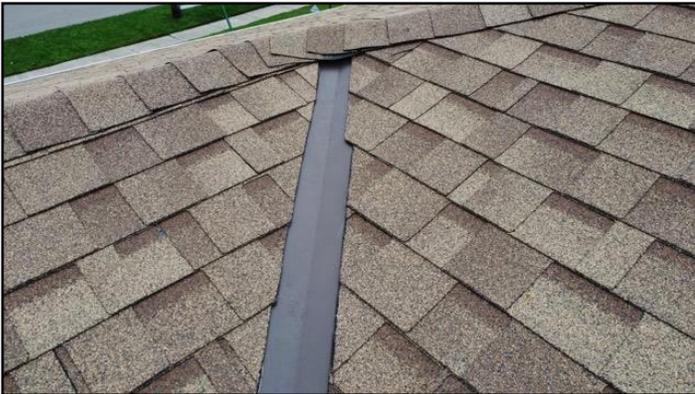
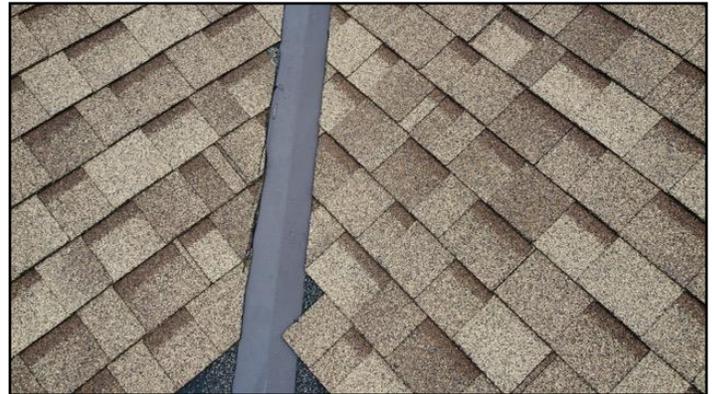
3. Condition: • [Doesn't widen at bottom](#)

Implication(s): Chance of water damage to structure, finishes and contents

10. Doesn't widen at bottom

11. Doesn't widen at bottom

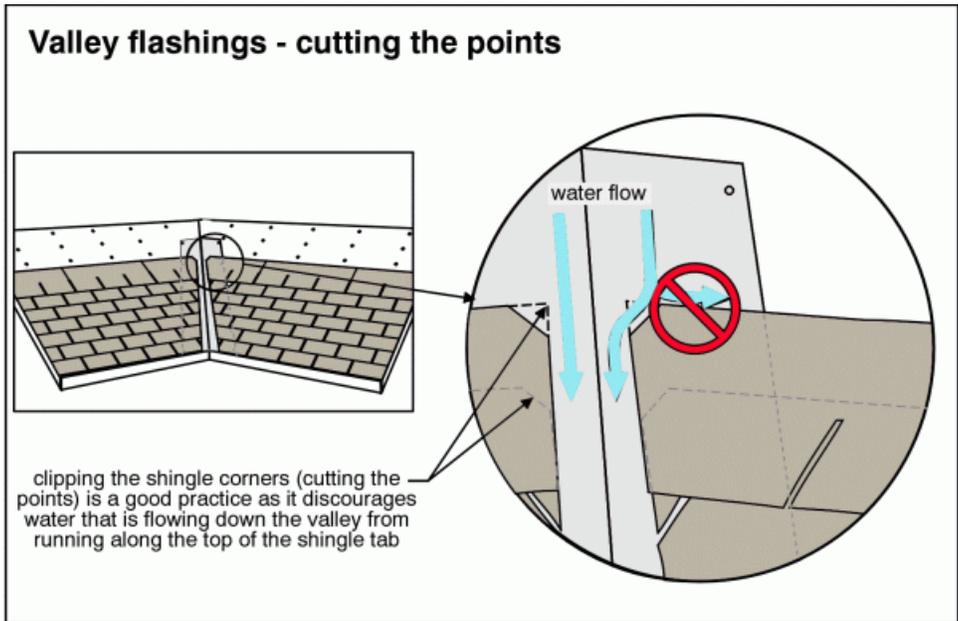
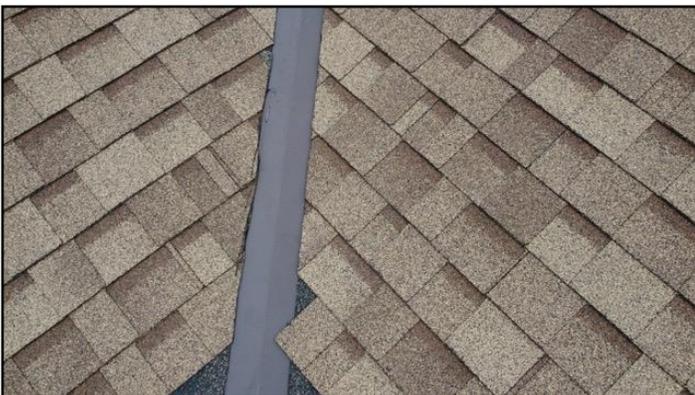
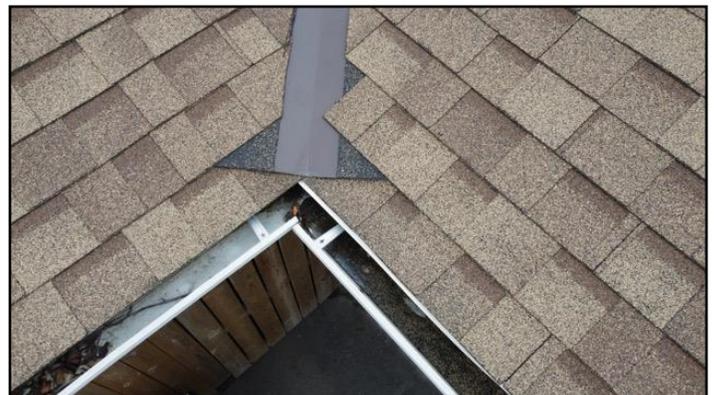
4. Condition: • [Points not cut](#)

Implication(s): Chance of water damage to structure, finishes and contents

12. Points not cut

13. Points not cut

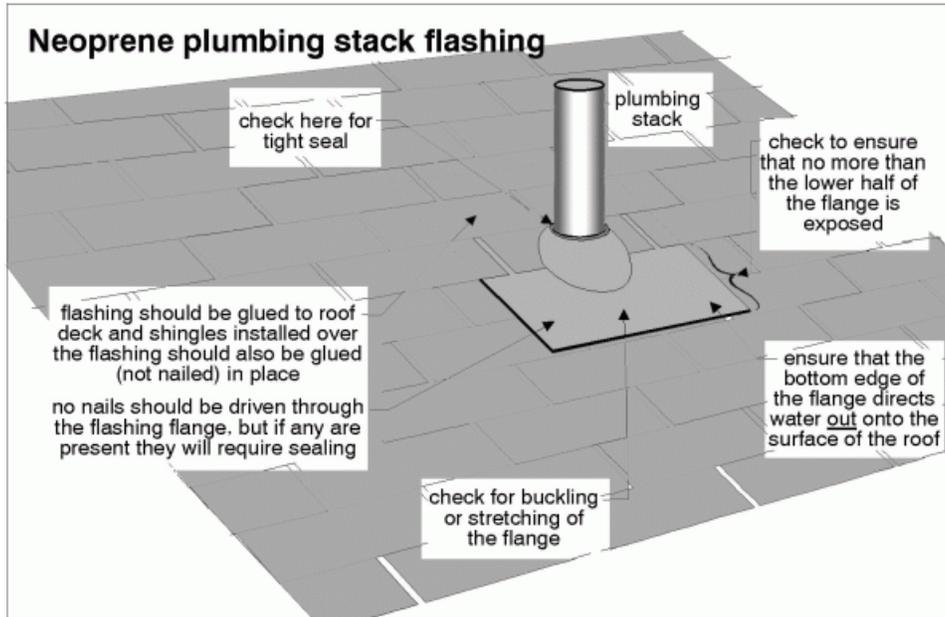
5. Condition: • [Fasteners - exposed / missing](#)

Implication(s): Chance of water damage to structure, finishes and contents

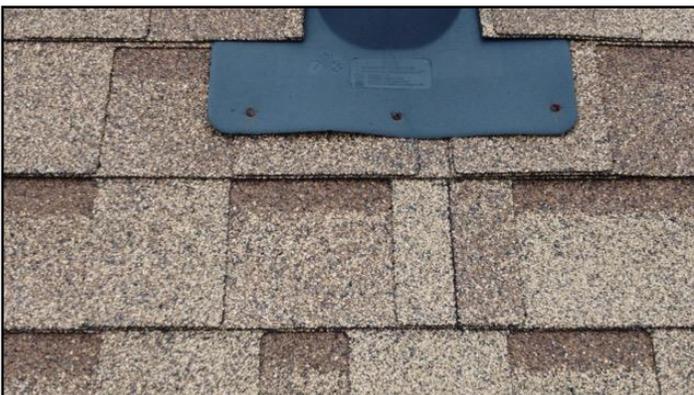
6. Condition: • [Exposed fasteners not sealed](#)

Implication(s): Chance of water damage to structure, finishes and contents

Location: Throughout

14. Exposed fasteners not sealed

Task: Repair

Time: As soon as practical

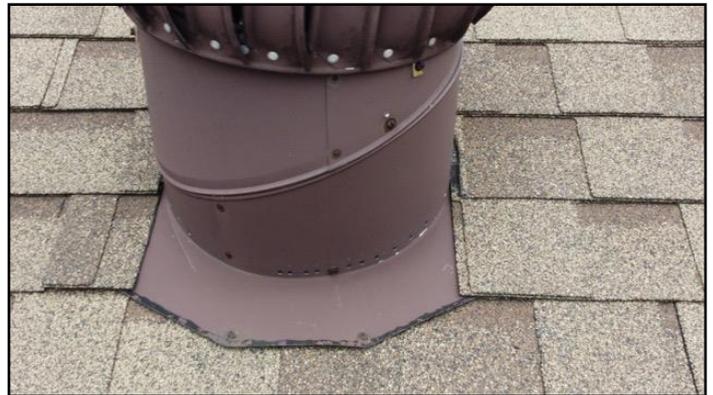
19. Exposed fasteners not sealed

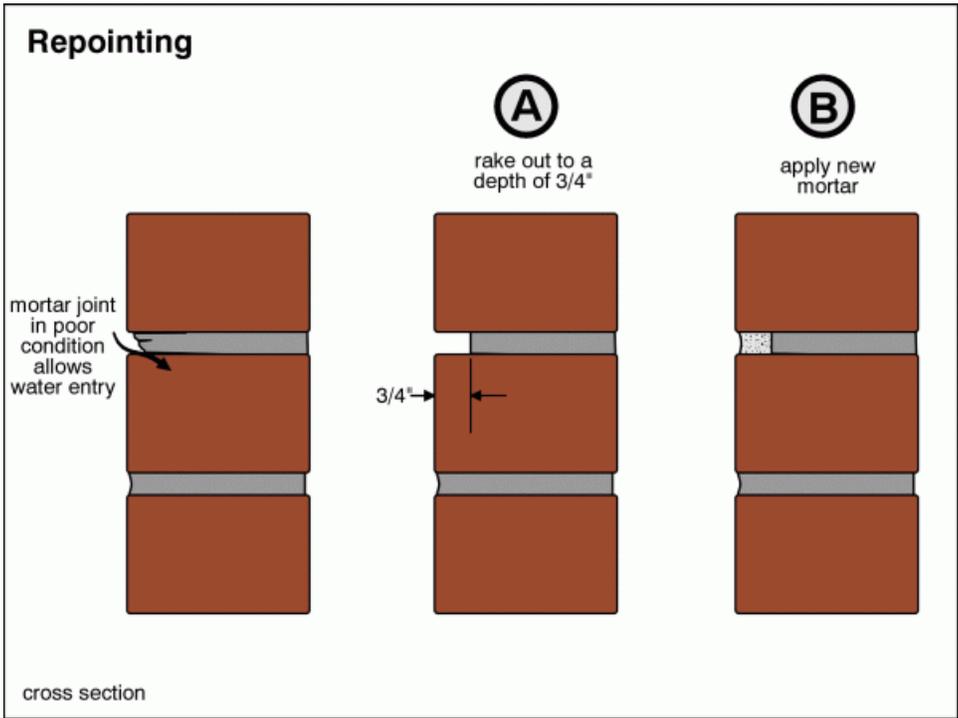
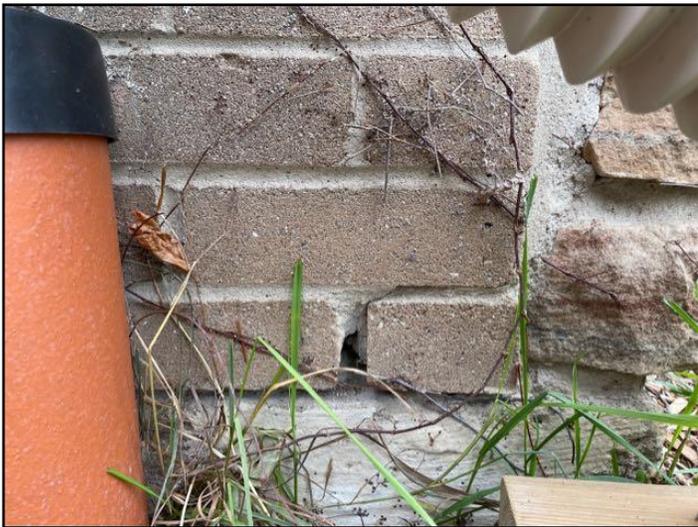
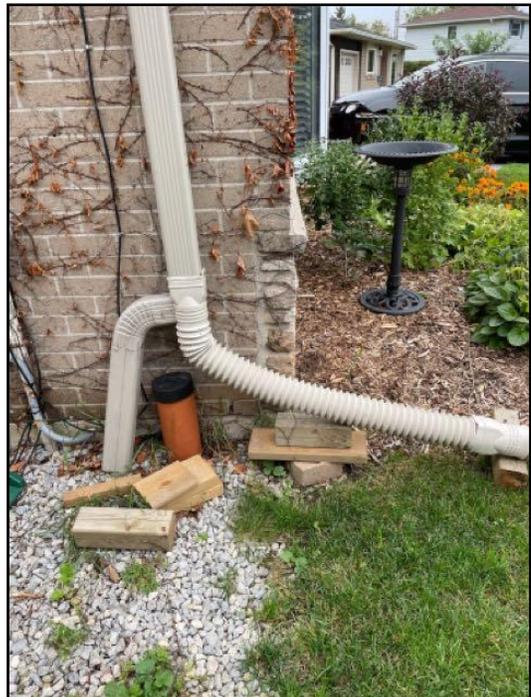
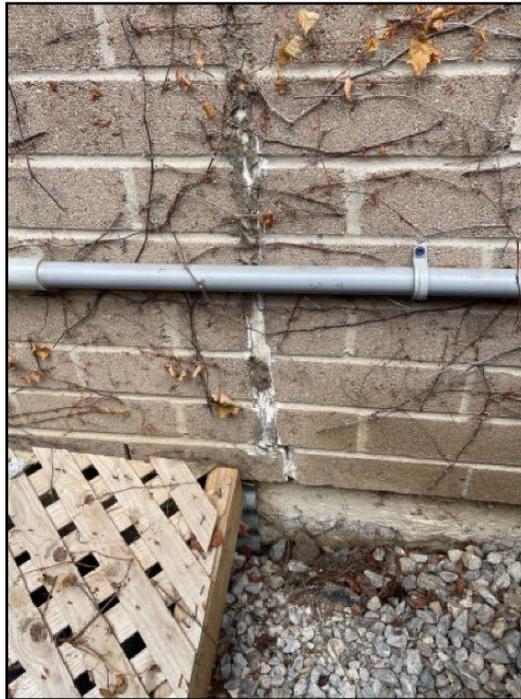
7. **Condition:** • [Mortar deterioration](#)

Implication(s): Chance of water entering building | Weakened structure | Chance of structural movement

Location: Left Exterior

28. Mortar deterioration

29. Mortar deterioration

30. Mortar deterioration

Task: Repair

Time: As soon as practical

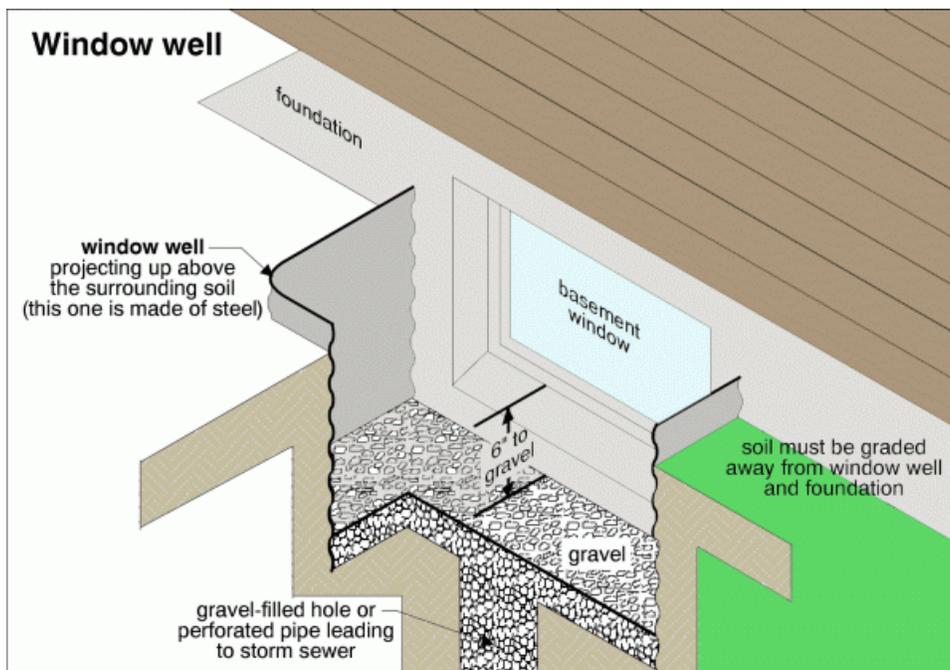
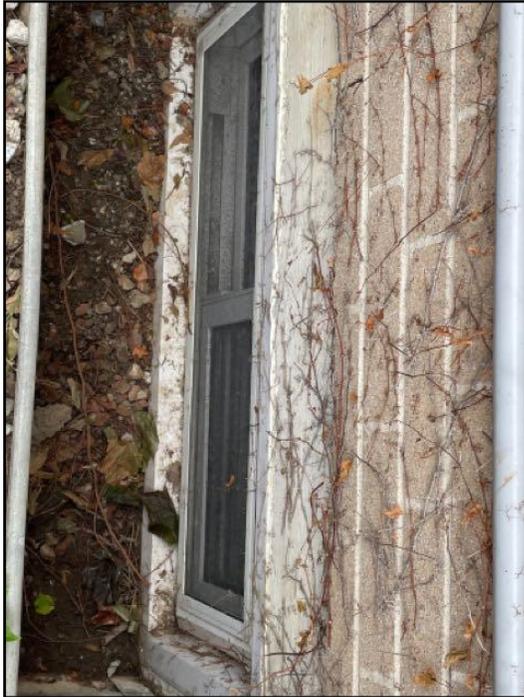
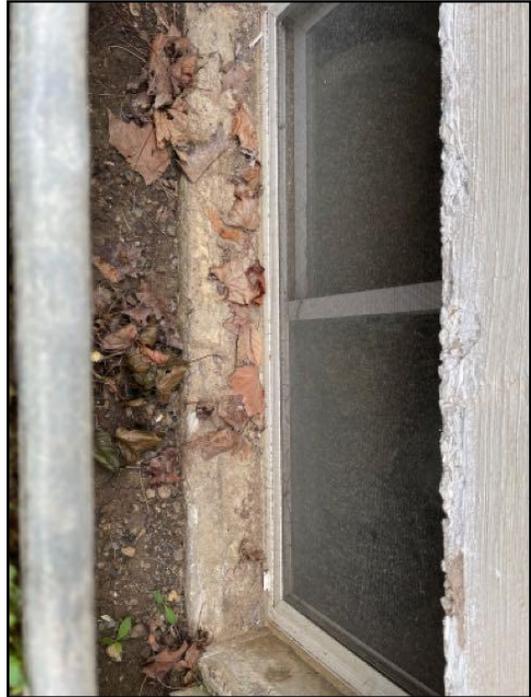
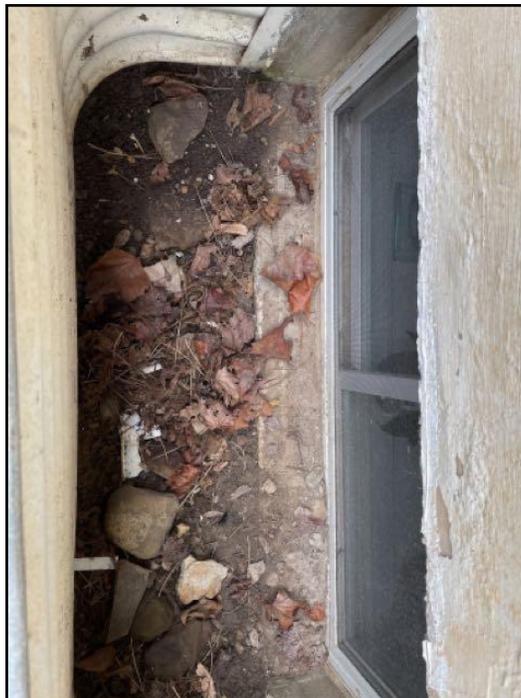
8. Condition: • [Less than 6 inches below window](#)

Implication(s): Chance of water entering building

Location: Throughout Exterior

31. Less than 6 inches below window

32. Less than 6 inches below window

33. Less than 6 inches below window

Task: Improve

Time: As soon as practical

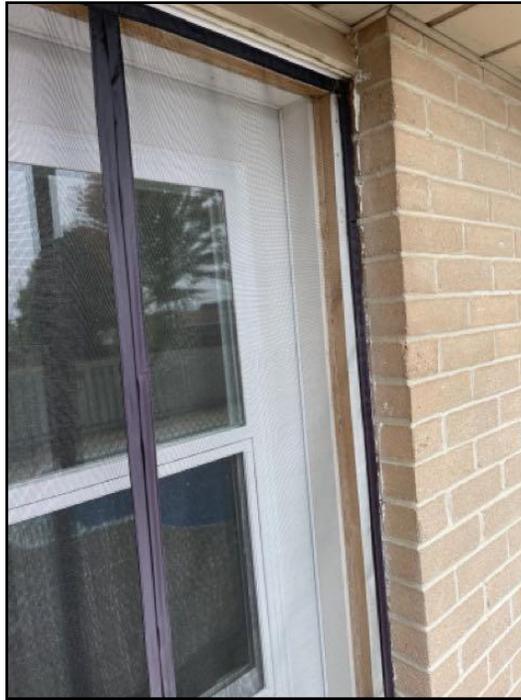
34.

9. **Condition:** • Exposed wood on door trim

Location: Right Side Exterior

Task: Repair

Time: As soon as practical

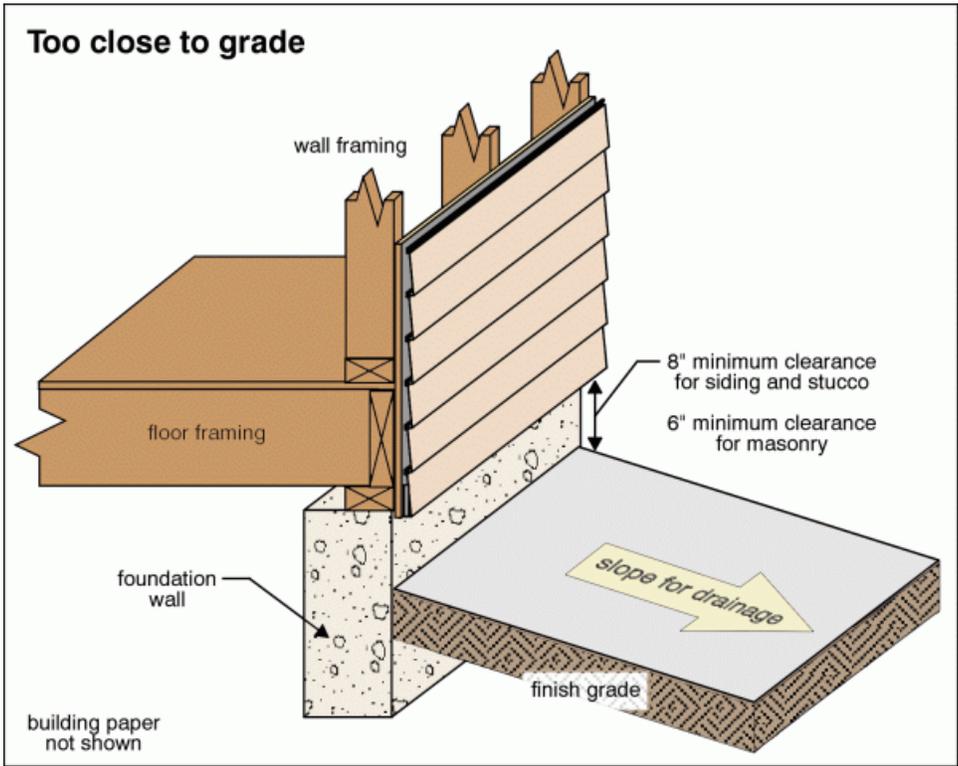
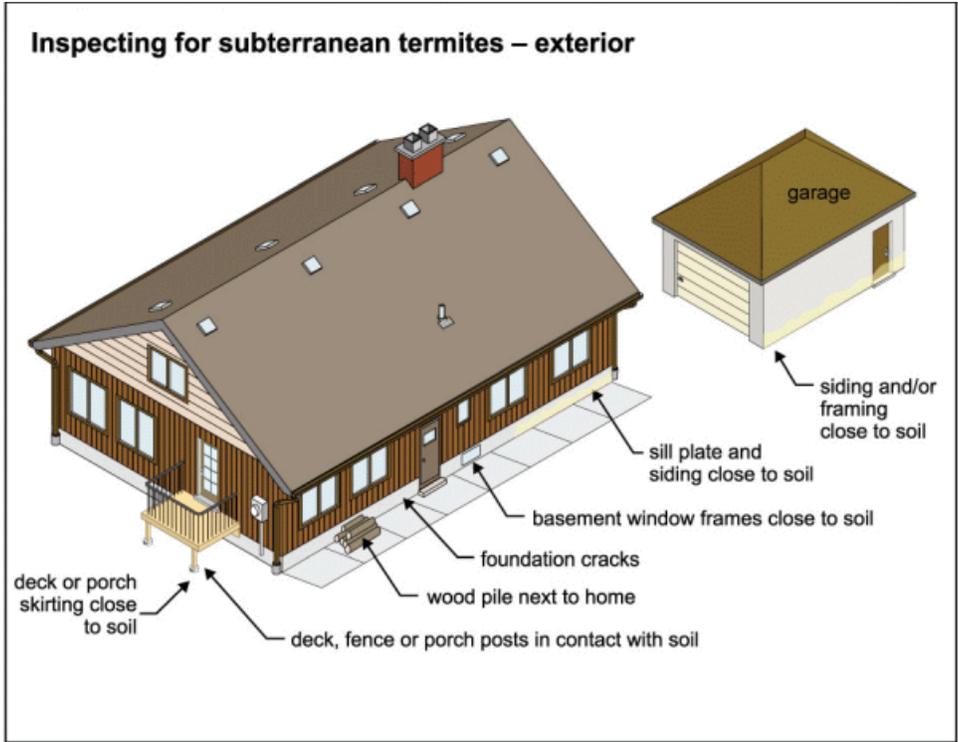
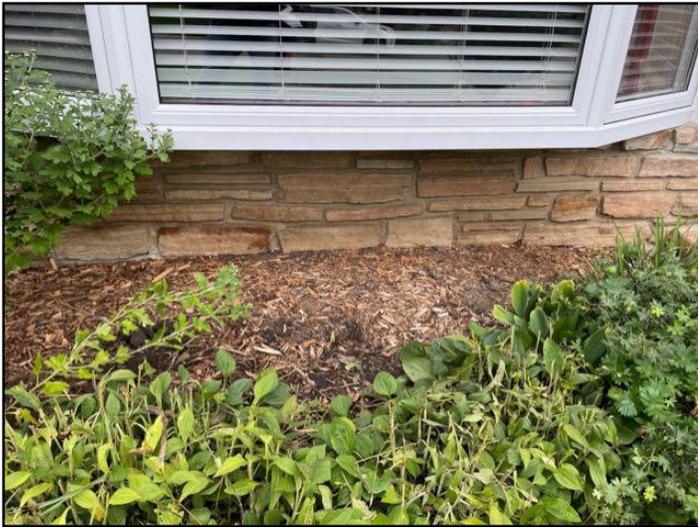
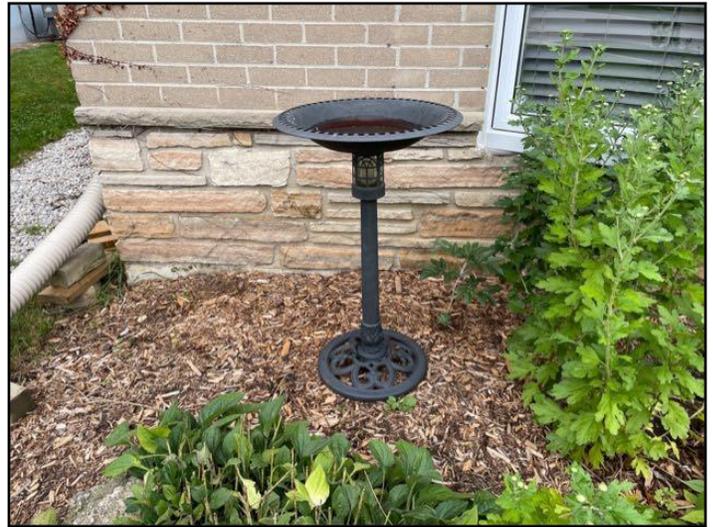
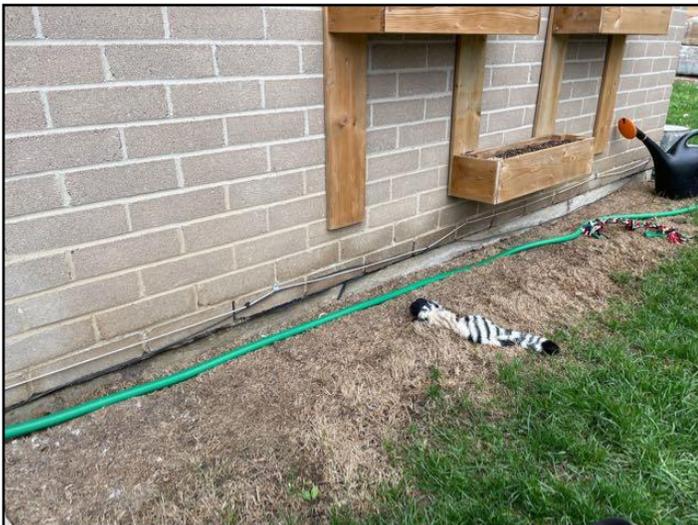
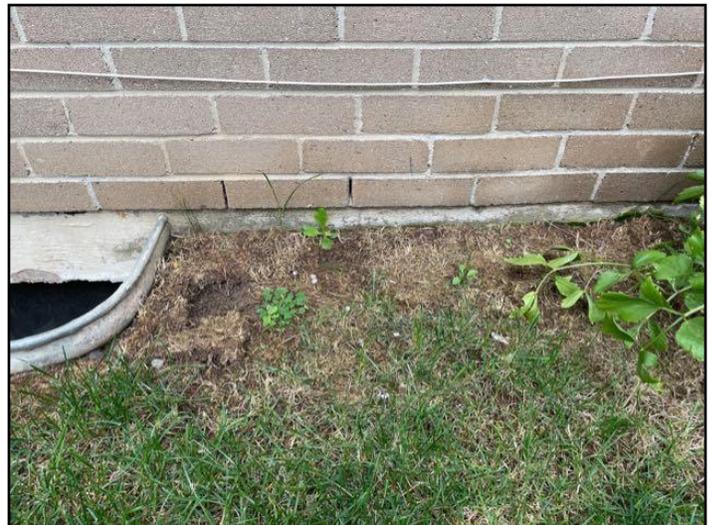
10. Condition: • [Too close to grade or wood/soil contact](#)

Implication(s): Chance of water entering building | Weakened structure | Rot | Insect damage

Location: Throughout

35. Too close to grade or wood/soil contact

36. Too close to grade or wood/soil contact

37. Too close to grade or wood/soil contact

38. Too close to grade or wood/soil contact

Task: Improve

Time: As soon as practical

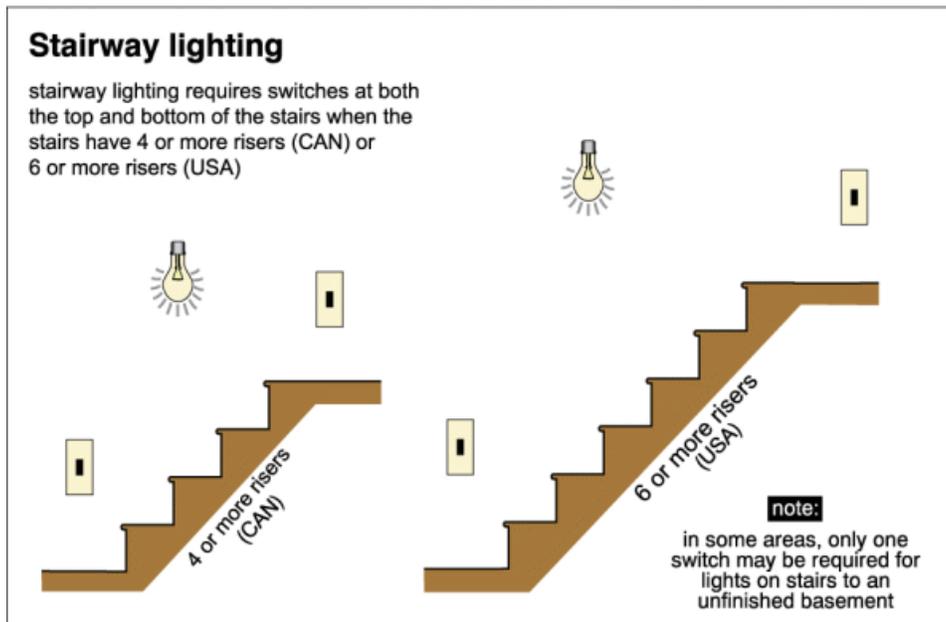
12. Condition: • 3-way not working as intended

Switch and dining room and hallway by bedrooms

Implication(s): Nuisance | Fall hazard

Location: First Floor Dining Room

Task: Repair

Time: When necessary

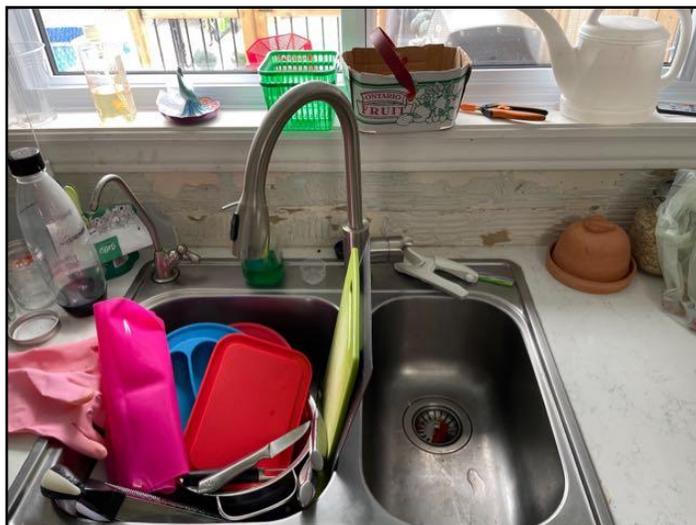
13. Condition: • [Loose](#)

Implication(s): Equipment failure

Location: Kitchen First Floor

63. Loose

Task: Repair

Time: When necessary

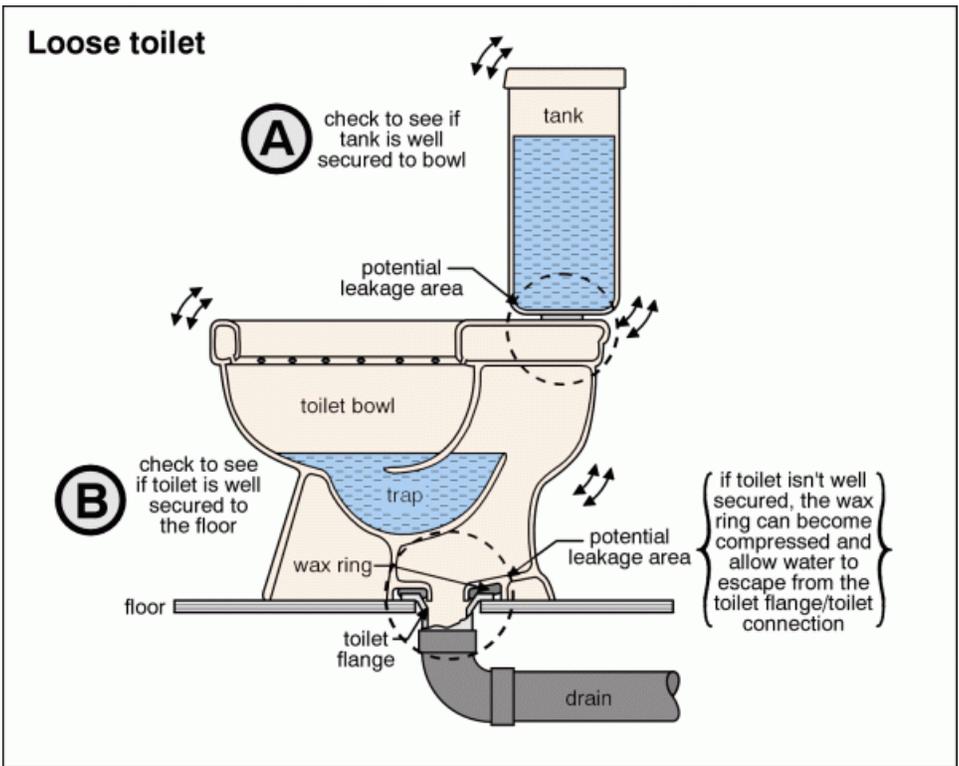
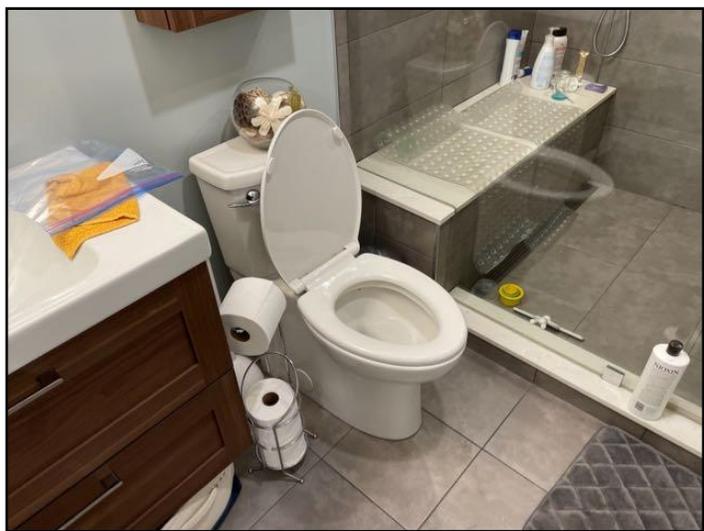
14. Condition: • [Loose](#)

Implication(s): Chance of water damage to structure, finishes and contents | Sewage entering the building | Possible hidden damage

Location: Basement Bathroom

64. Loose

Task: Repair

Time: As soon as possible

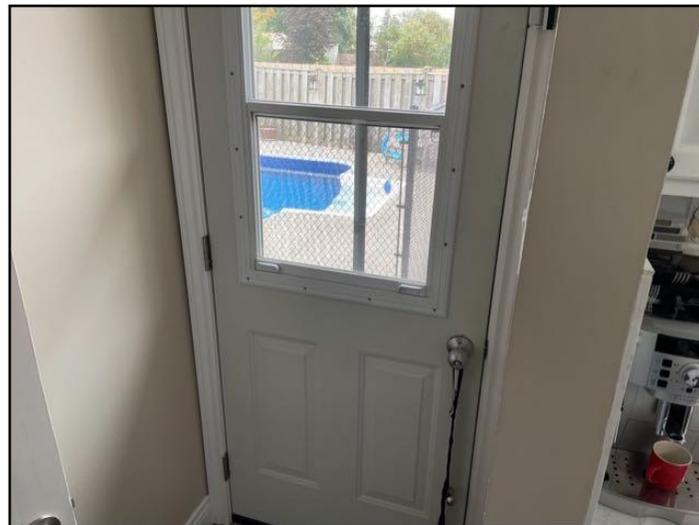
16. Condition: • [Stiff](#)

Implication(s): Reduced operability

Location: First Floor Kitchen

65. *Stiff*

Task: Repair

Time: When necessary

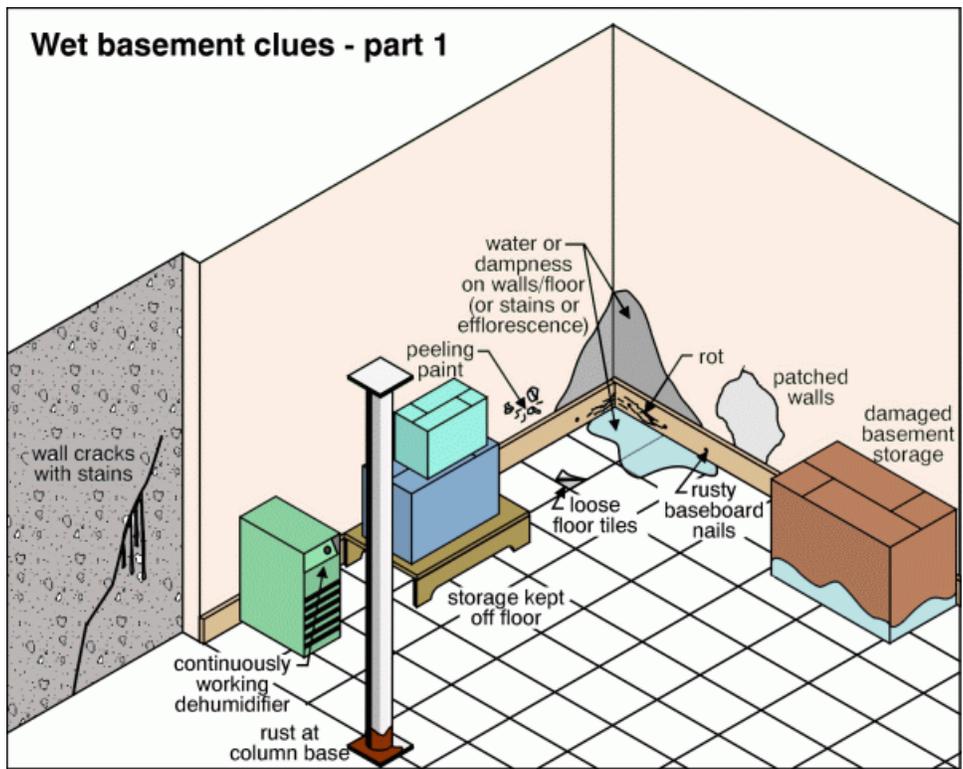
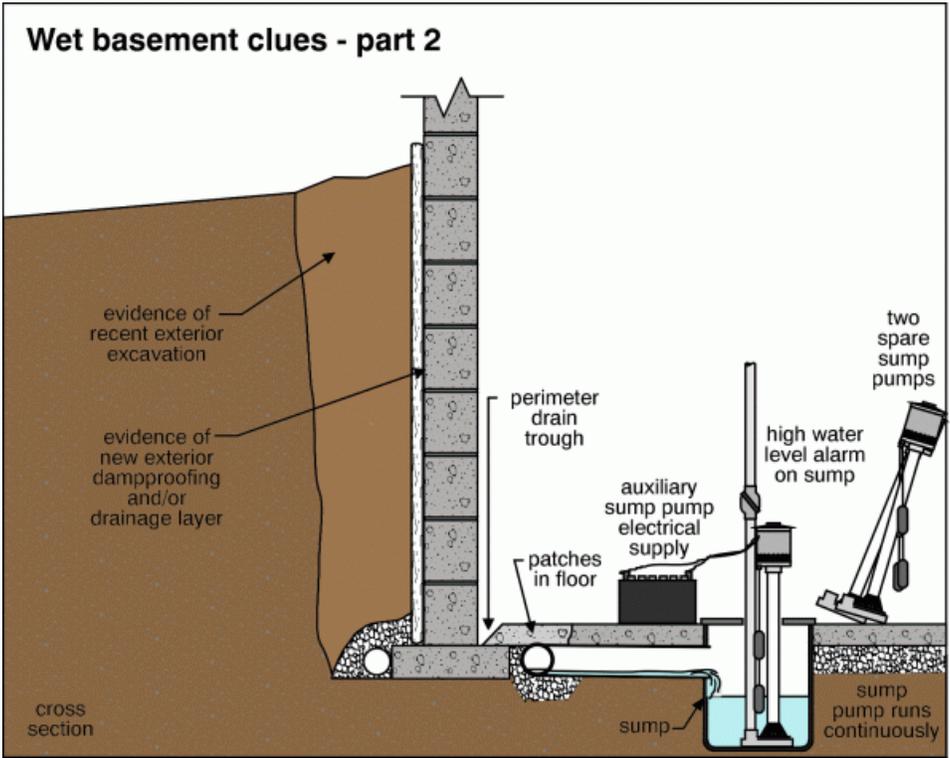
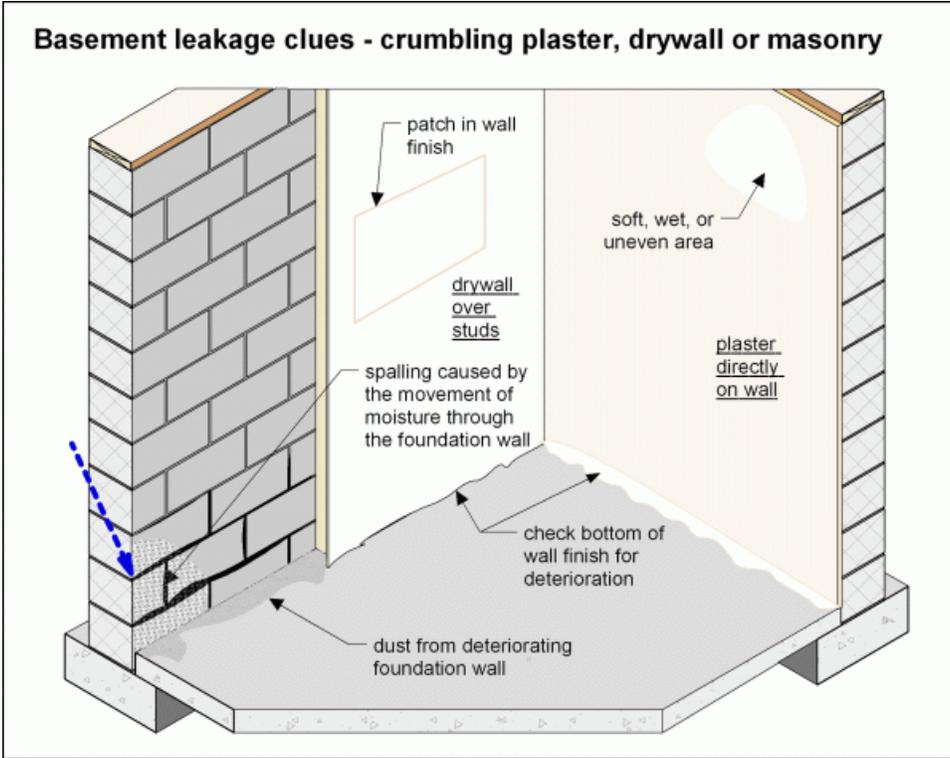
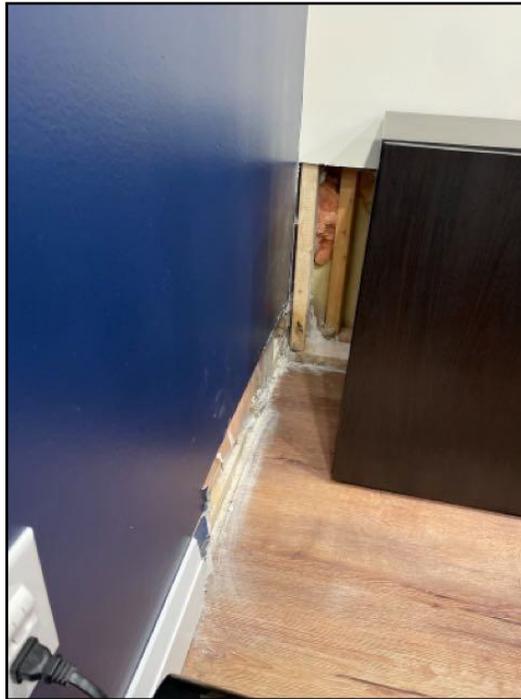
18. Condition: • [Crumbling plaster, dry wall or concrete walls](#)

Implication(s): Chance of water damage to structure, finishes and contents | Material deterioration

Location: Basement Family Room

66. *Crumbling plaster, dry wall or concrete walls*

Task: Repair

Time: As soon as possible

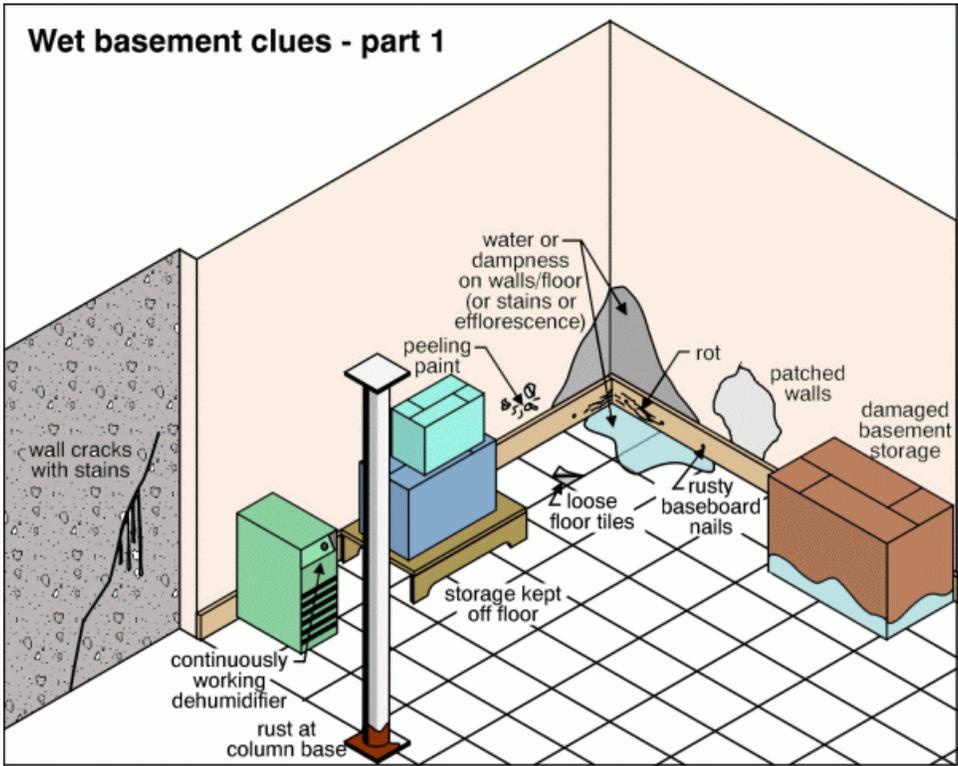
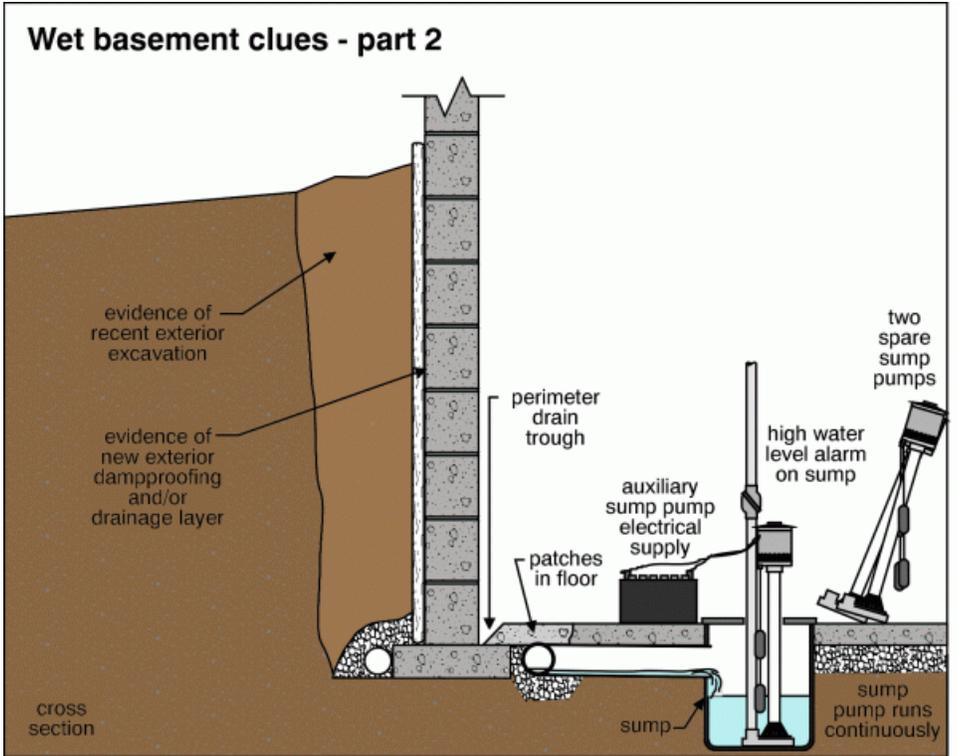
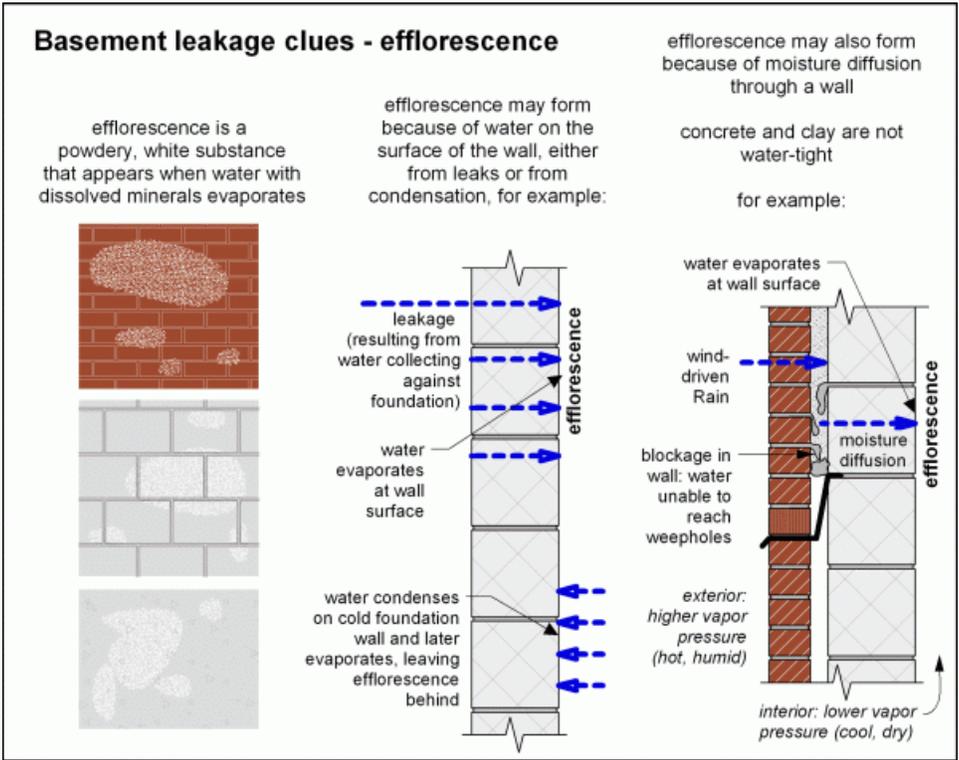
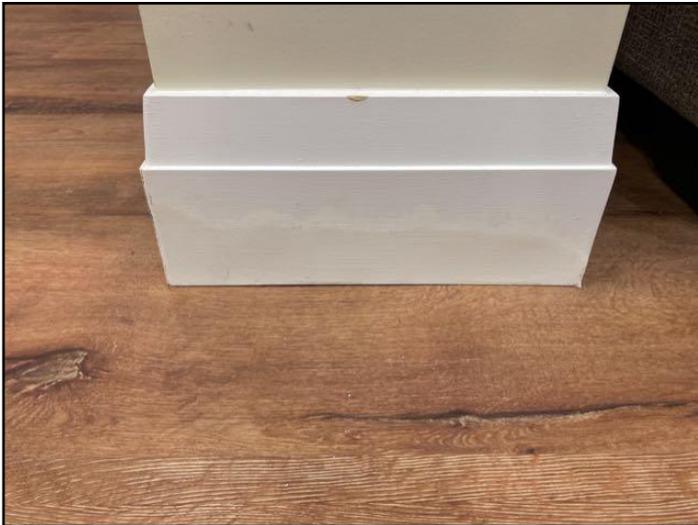
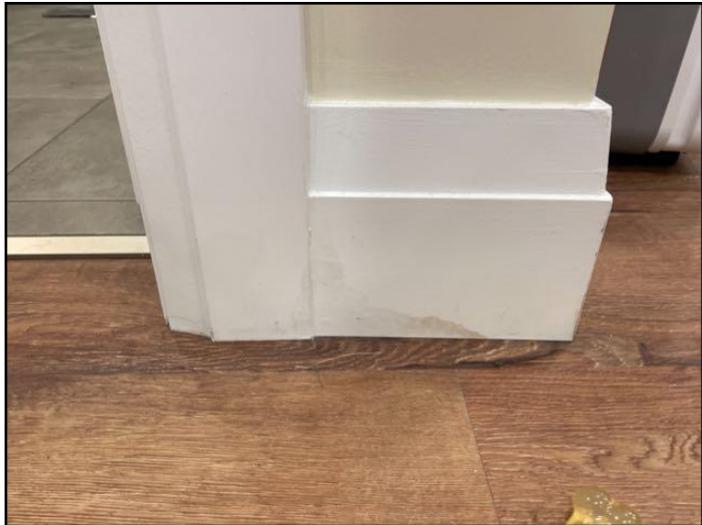
19. Condition: • [Efflorescence](#)

Implication(s): Chance of water damage to structure, finishes and contents

Location: Basement Family Room

67. Efflorescence

68. Efflorescence

Task: Correct

Time: When necessary
