YOUR INSPECTION REPORT

123 Any St
Georgetown, ON

Friday, October 8, 2021

RE: Report No. 1004, v.2
123 Any St
Georgetown, ON

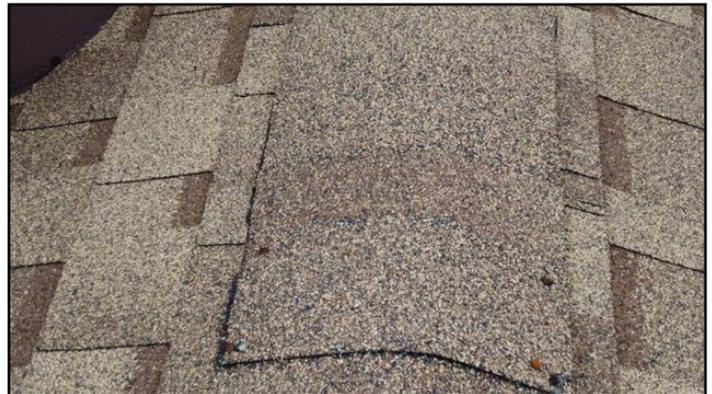
1. Condition: • [Exposed fasteners](#)

Implication(s): Chance of water damage to structure, finishes and contents

Location: Throughout

6. Exposed fasteners

Task: Repair

Time: As soon as practical

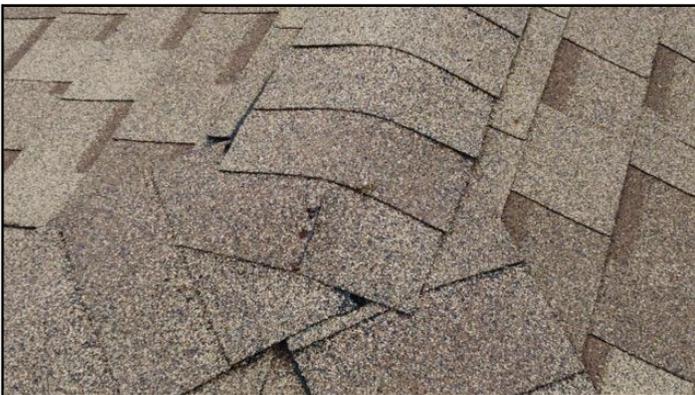
7. Exposed fasteners

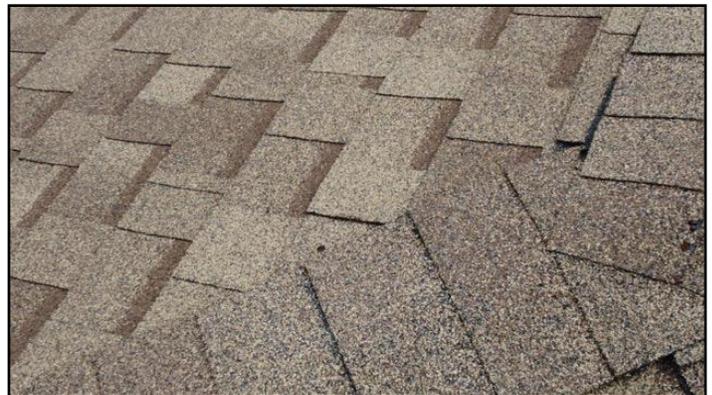
8. Exposed fasteners

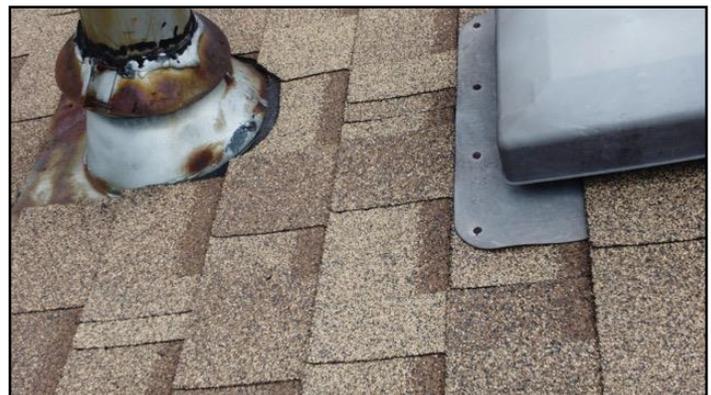
6. Condition: • [Exposed fasteners not sealed](#)

Implication(s): Chance of water damage to structure, finishes and contents

15. Exposed fasteners not sealed

Task: Repair

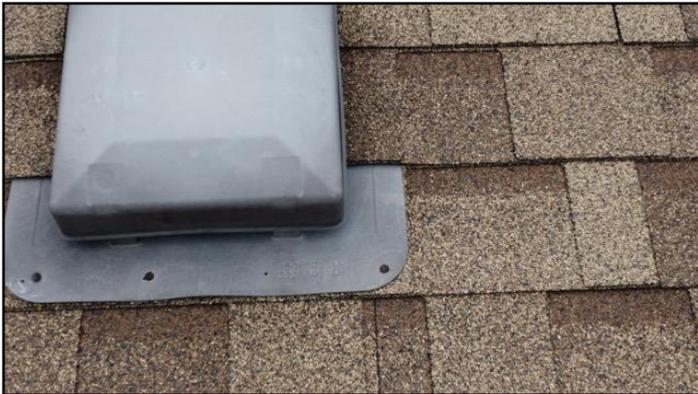
16. Exposed fasteners not sealed

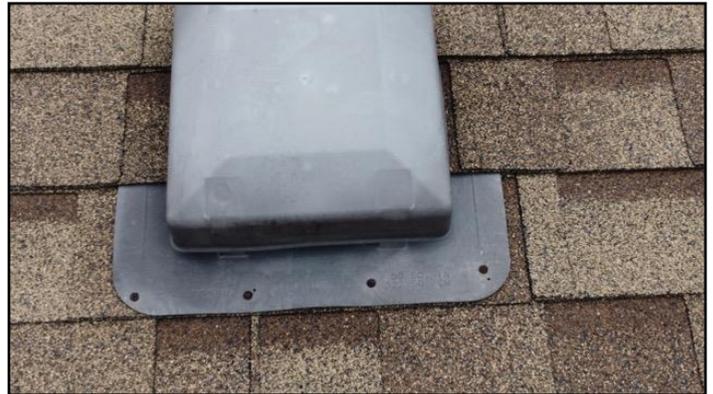
17. Exposed fasteners not sealed

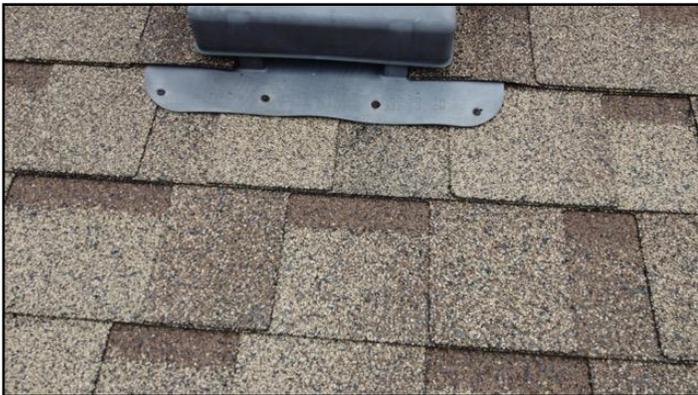
18. Exposed fasteners not sealed

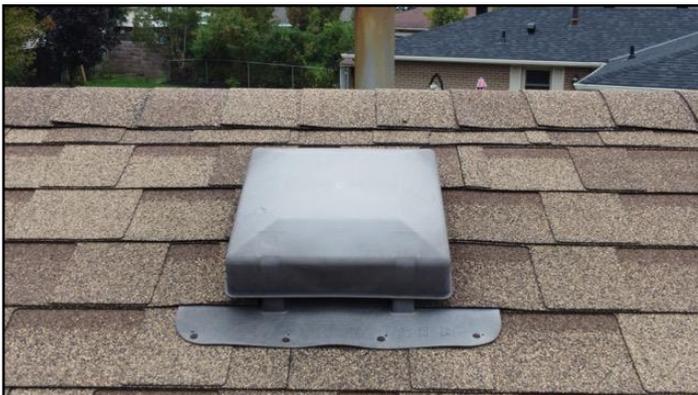
20. Exposed fasteners not sealed

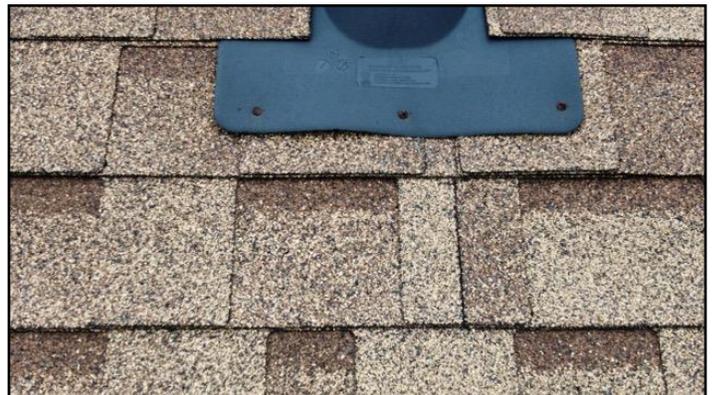
21. Exposed fasteners not sealed
